MIRADA
COMMUNITY DEVELOPMENT DISTRICT

Advanced Meeting Package

**Mirada Community
Development District
Sign Analysis
Mirada Blvd. and Setter Palm**

SUMMARY OF SIGN INVENTORY

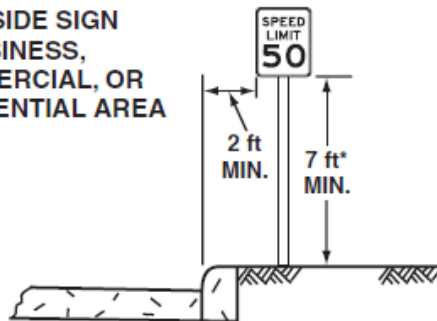
**C - ROADSIDE SIGN
IN BUSINESS,
COMMERCIAL, OR
RESIDENTIAL AREA**

*Where parking or pedestrian movements are likely to occur

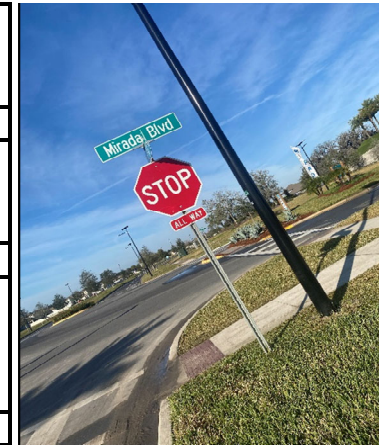
Inventory Sign Number	On Roadway	Sign	Size	MUTCD Minimum Sign Size	MUTCD Minimum Size Met
1	Mirada Blvd @Settler Palm Rd	STOP SIGN (R1-1)	30"x30"	30"x30"	YES
			Height to Bottom of Sign	MUTCD Minimum Height	MUTCD Minimum Height Met
			7'-1"	7'-0"	YES
			Offset from Face of Curb to Edge of Sign	MUTCD Minimum Offset	MUTCD Minimum Offset Met
			2'-7"	1'-6"	YES

NOTES: Meets MUTCD Standards

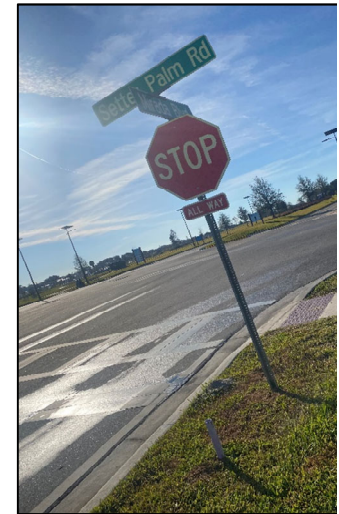
Inventory Sign Number	On Roadway	Sign	Size	MUTCD Minimum Sign Size	MUTCD Minimum Size Met
2	Mirada Blvd @Settler Palm Rd	Stop Sign	24"x30"	24"x30"	YES
		All Way	18"x18"	18"x18"	YES
			Height to Bottom of Sign	MUTCD Minimum Height	MUTCD Minimum Height Met
			6'-10"	7'-0"	NO
			6'-3"	6'-0"	YES
			Offset from Face of Curb to Edge of Sign	MUTCD Minimum Offset	MUTCD Minimum Offset Met
			1'-6"	1'-6"	YES

NOTES: Stop Sign is to be 7'-0" from ground to bottom of stop sign.

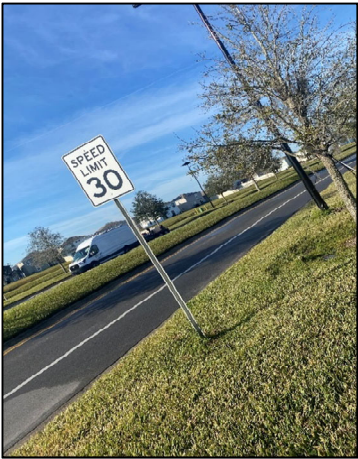
Inventory Sign Number	On Roadway	Sign	Size	MUTCD Minimum Sign Size	MUTCD Minimum Size Met
3	Mirada Blvd @Settler Palm Rd	SPEED LIMIT (R2-1)	24"x30"	24"x30"	YES
			Height to Bottom of Sign	MUTCD Minimum Height	MUTCD Minimum Height Met
			7'-1"	7'-0"	YES
			Offset from Face of Curb to Edge of Sign	MUTCD Minimum Offset	MUTCD Minimum Offset Met
			2'-7"	1'-6"	YES

NOTES: Meets MUTCD Standards

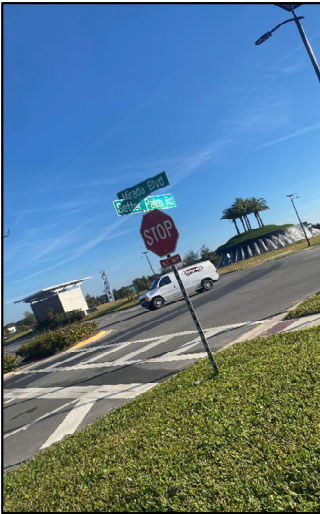
Inventory Sign Number	On Roadway	Sign	Size	MUTCD Minimum Sign Size	MUTCD Minimum Size Met
4	Mirada Blvd @Settler Palm Rd	Stop Sign	24"x30"	24"x30"	YES
		All Way	18"x18"	18"x18"	YES
			Height to Bottom of Sign	MUTCD Minimum Height	MUTCD Minimum Height Met
			7'-1"	7'-0"	YES
			6'-5"	6'-0"	YES
			Offset from Face of Curb to Edge of Sign	MUTCD Minimum Offset	MUTCD Minimum Offset Met
			1'-9"	1'-6"	YES

NOTES: Meets MUTCD Standards

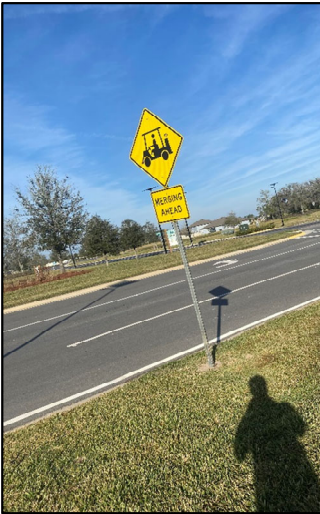
Inventory Sign Number	On Roadway	Sign	Size	MUTCD Minimum Sign Size	MUTCD Minimum Size Met
5	Mirada Blvd @Settler Palm Rd	Crossing	30"x30"	30"x30"	YES
		Ahead	18"x18"	18"x18"	YES
			Height to Bottom of Sign	MUTCD Minimum Height	MUTCD Minimum Height Met
			7'-1"	7'-0"	YES
			6'-5"	6'-0"	YES
			Offset from Face of Curb to Edge of Sign	MUTCD Minimum Offset	MUTCD Minimum Offset Met
			1'-7"	1'-6"	YES

NOTES: Meets MUTCD Standards

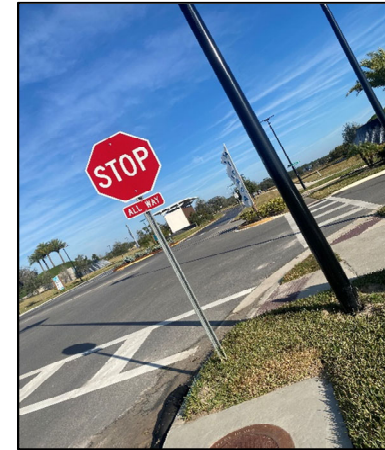
Inventory Sign Number	On Roadway	Sign	Size	MUTCD Minimum Sign Size	MUTCD Minimum Size Met
6	Mirada Blvd @Settler Palm Rd	STOP SIGN (R1-1)	30"x30"	30"x30"	YES
			Height to Bottom of Sign	MUTCD Minimum Height	MUTCD Minimum Height Met
			7'-0"	7'-0"	YES
			Offset from Face of Curb to Edge of Sign	MUTCD Minimum Offset	MUTCD Minimum Offset Met
			0'-1"	1'-6"	NO

NOTES: Sign is missing street names
and sign offset is required to be 1'-6" from back of curb

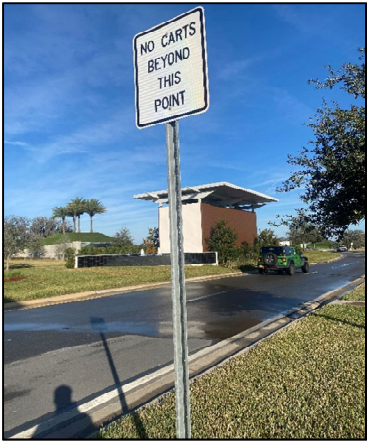
Inventory Sign Number	On Roadway	Sign	Size	MUTCD Minimum Sign Size	MUTCD Minimum Size Met
7	Mirada Blvd @Settler palm Rd	No Carts Sign	24"x18"	24"x18"	YES
			Height to Bottom of Sign	MUTCD Minimum Height	MUTCD Minimum Height Met
			7'-4"	7'-0"	YES
			Offset from Face of Curb to Edge of Sign	MUTCD Minimum Offset	MUTCD Minimum Offset Met
			3'-0"	1'-6"	YES

NOTES: Meets MUTCD Standards

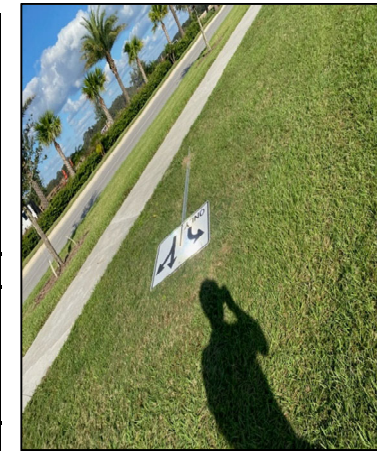
Inventory Sign Number	On Roadway	Sign	Size	MUTCD Minimum Sign Size	MUTCD Minimum Size Met
8	Mirada Blvd @Settler palm Rd	Lane Control R3-8	30"x30"	30"x30"	YES
			Height to Bottom of Sign	MUTCD Minimum Height	MUTCD Minimum Height Met
			7'-4"	7'-0"	YES
			Offset from Face of Curb to Edge of Sign	MUTCD Minimum Offset	MUTCD Minimum Offset Met
			3'-0"	1'-6"	YES

NOTES: Sign to be installed 1'-6" offset from Back of Curb and 7'-0" minimum from the ground to the bottom of the sign

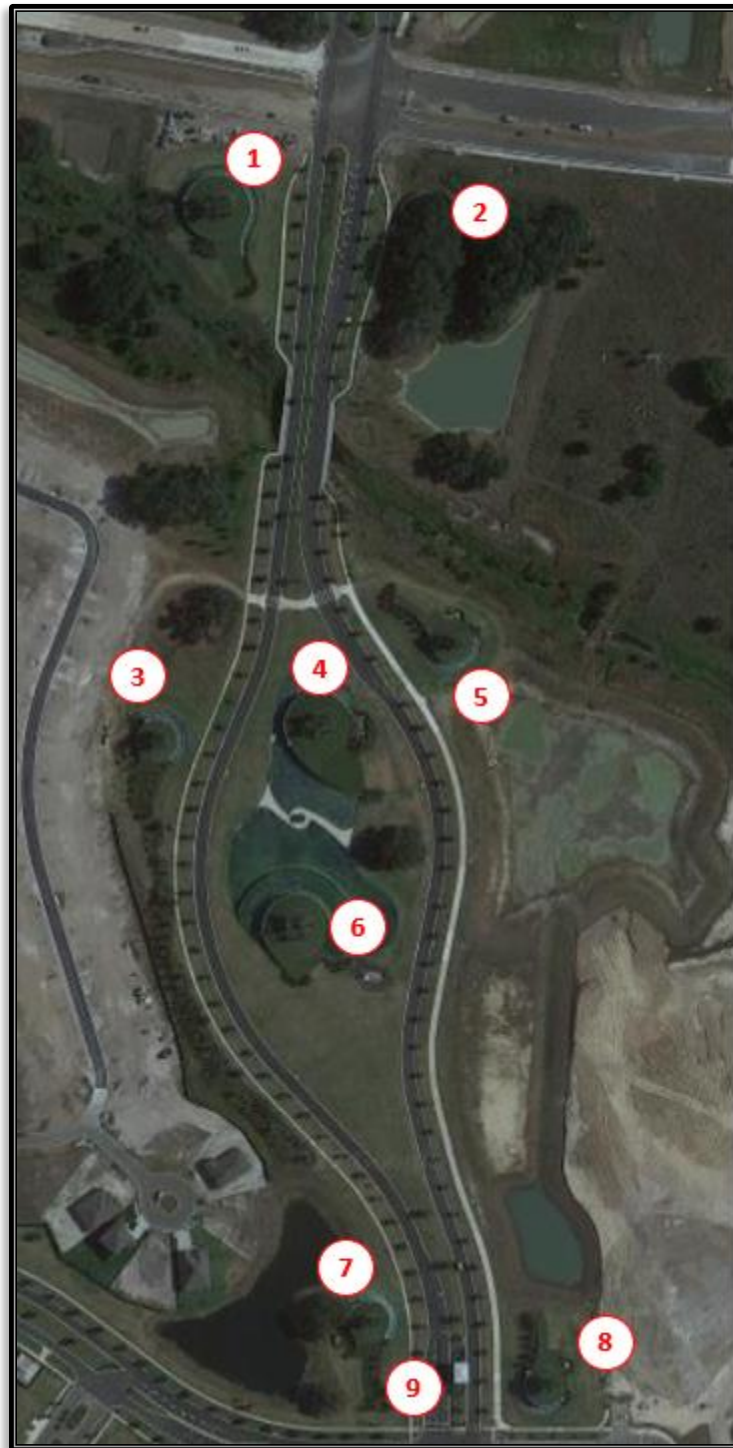
Fountain 1:

- Water: clean
- Cannons: limited functionality (can't run all day)
- Lights: all functional
- Filtration: functional
- Other:
 - Investigating issue with feature motor (original motor). Believe that the bearings are deteriorating. Will need to pull the motor to confirm/repair. Getting quotes.
 - Securing proposal for tile repair
 - Securing proposal for painting bottom of pool
 - Scheduling fence work
 - Monitoring/investigating possible structural leaks (excess water around fountain)

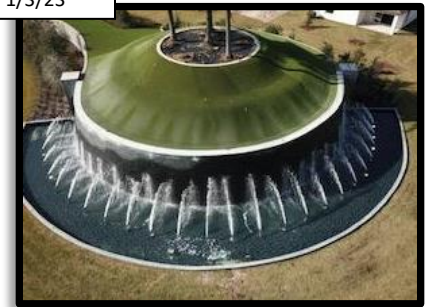
Fountain 3:

- Water: clean
- Cannons: all functional
- Lights: all functional
- Filtration: functional
- Other:
 - Securing proposal for tile repair
 - Securing proposal for painting bottom of pool
 - Scheduling fence work
 - Monitoring/investigating possible structural leaks (excess water around fountain)

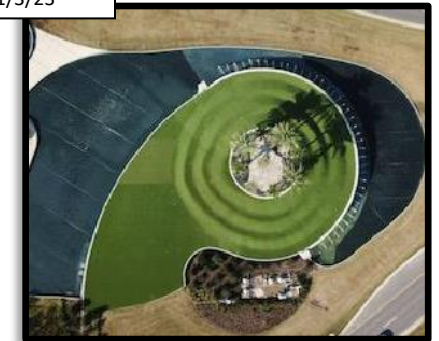
Fountain 4:

- Water: clean
- Cannons: all functional
- Lights: all functional
- Filtration: functional
- Other:
 - Securing proposal for painting bottom of pool
 - Scheduling fence work
 - Monitoring/investigating possible structural leaks (excess water around fountain)

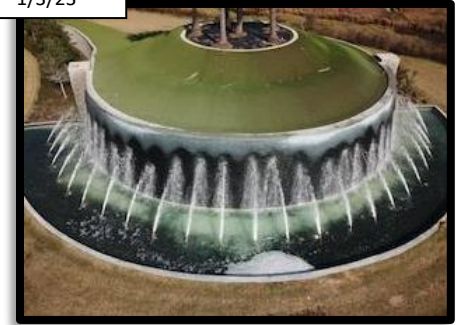
Fountain 5:

- Water: clean
- Cannons: all functional
- Lights: all functional
- Filtration: functional
- Other:
 - Securing proposal for tile repair
 - Securing proposal for painting bottom of pool
 - Scheduling fence work
 - Monitoring/investigating possible structural leaks (excess water around fountain)

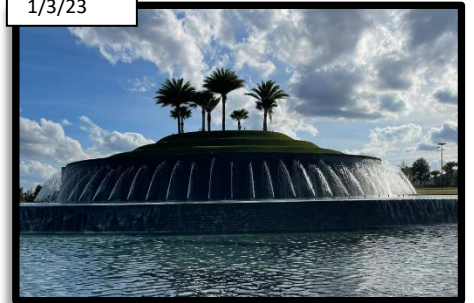
Fountain 6:

- Water: clean
- Cannons: all functional
- Lights: all functional
- Filtration: functional
- Other:
 - Securing proposal for painting bottom of upper pool
 - Scheduling fence work
 - Monitoring/investigating possible structural leaks (excess water around fountain)

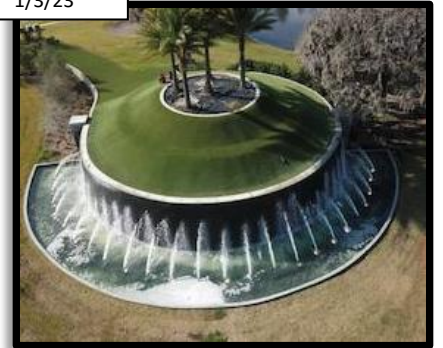
Fountain 7:

- Water: clean
- Cannons: all functional
- Lights: all functional
- Filtration: functional
- Other:
 - Securing proposal for tile repair
 - Securing proposal for painting bottom of pool
 - Scheduling fence work
 - Monitoring/investigating possible structural leaks (excess water around fountain)

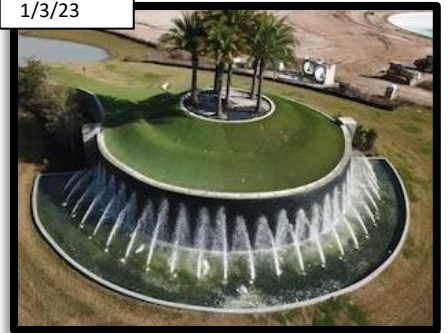
Fountain 8:

- Water: clean
- Cannons: all functional
- Lights: all functional
- Filtration: functional
- Other:
 - Securing proposal for tile repair
 - Securing proposal for painting bottom of pool
 - Scheduling fence work
 - Monitoring/investigating possible structural leaks (excess water around fountain)

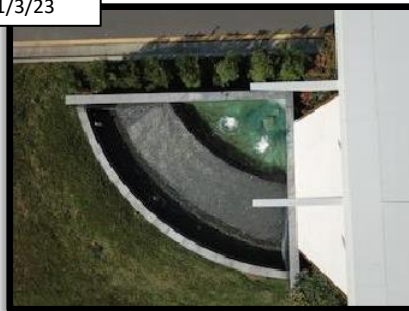
Fountain 9:

- Water: clean
- Lights: all functional
- Filtration: functional
- Other:
 - Securing proposal for tile repair
 - Securing proposal for painting bottom of pool
 - Monitoring/investigating possible structural leaks (excess water around fountain)

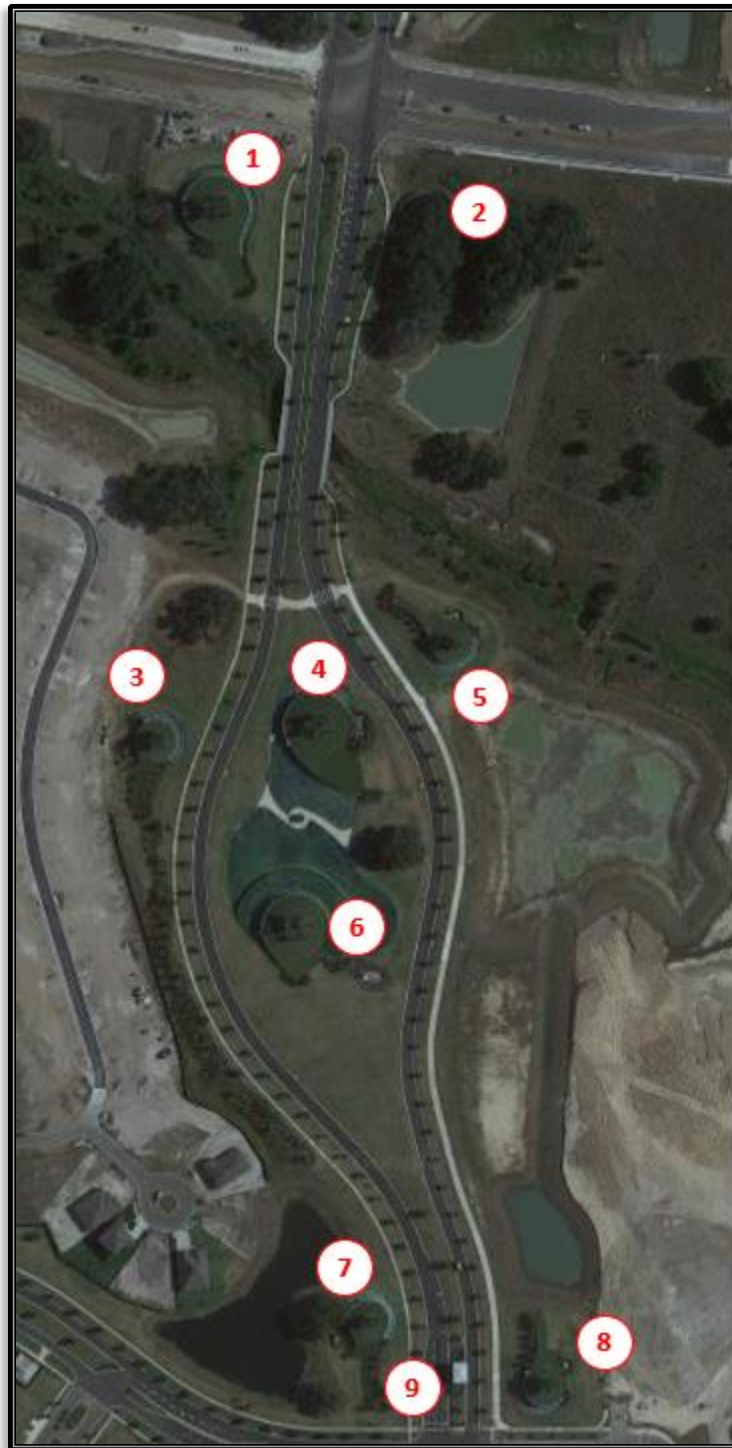
Fountain 1:

- Water: clean
- Cannons: not functioning due to feature motor repair
- Lights: all functional
- Filtration: functional
- Other:
 - Repairs to the feature motor are ongoing. Motor is very old leading to some challenges. The vendor is working to expedite.
 - Securing proposal for tile repair
 - Securing proposal for painting bottom of pool
 - Scheduling fence work
 - Monitoring/investigating possible structural leaks (excess water around fountain)

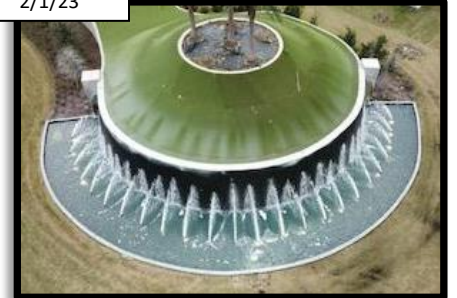
Fountain 3:

- Water: clean
- Cannons: all functional
- Lights: all functional
- Filtration: functional
- Other:
 - Securing proposal for tile repair
 - Securing proposal for painting bottom of pool
 - Scheduling fence work
 - Monitoring/investigating possible structural leaks (excess water around fountain)

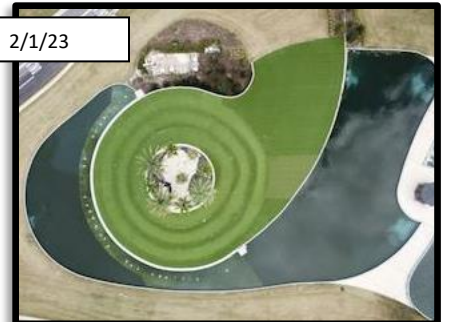
Fountain 4:

- Water: clean
- Cannons: not functional
- Lights: all functional
- Filtration: functional
- Other:
 - New motor overheated. Working with supplier to secure service under warranty.
 - Securing proposal for painting bottom of pool
 - Scheduling fence work
 - Monitoring/investigating possible structural leaks (excess water around fountain)

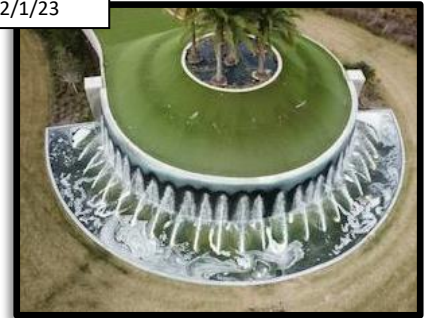
Fountain 5:

- Water: clean
- Cannons: all functional
- Lights: all functional
- Filtration: functional
- Other:
 - Securing proposal for tile repair
 - Securing proposal for painting bottom of pool
 - Scheduling fence work
 - Monitoring/investigating possible structural leaks (excess water around fountain)
 - The foaming is temporary due to addition of copper. Should be clear in 24 hours.

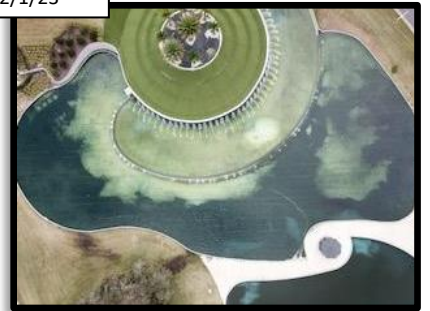
Fountain 6:

- Water: clean
- Cannons: all functional
- Lights: all functional
- Filtration: functional
- Other:
 - Securing proposal for painting bottom of upper pool
 - Scheduling fence work
 - Monitoring/investigating possible structural leaks (excess water around fountain)

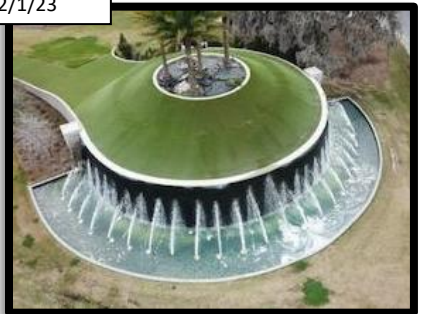
Fountain 7:

- Water: clean
- Cannons: all functional
- Lights: all functional
- Filtration: functional
- Other:
 - Securing proposal for tile repair
 - Securing proposal for painting bottom of pool
 - Scheduling fence work
 - Monitoring/investigating possible structural leaks (excess water around fountain)

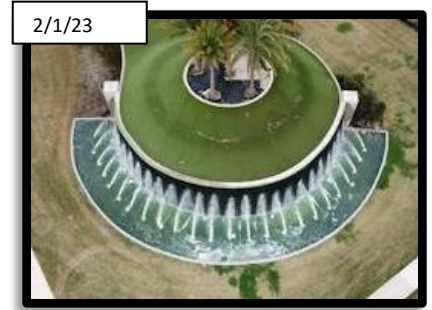
Fountain 8:

- Water: clean
- Cannons: all functional
- Lights: all functional
- Filtration: functional
- Other:
 - Securing proposal for tile repair
 - Securing proposal for painting bottom of pool
 - Scheduling fence work
 - Monitoring/investigating possible structural leaks (excess water around fountain)

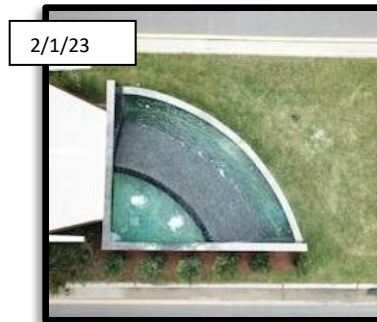
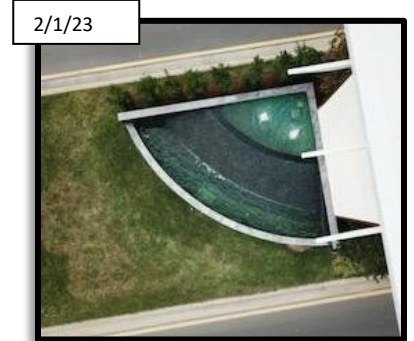
Fountain 9:

- Water: clean
- Lights: all functional
- Filtration: functional
- Other:
 - Securing proposal for tile repair
 - Securing proposal for painting bottom of pool
 - Monitoring/investigating possible structural leaks (excess water around fountain)
